NDI ID PA 00774
PA DER 45-136

HUNTER LAKE DAM

OWNED BY
THE GOLDEN SLIPPER SQUARE CLUB
PHASE I INSPECTION REPORT
NATIONAL DAM INSPECTION PROGRAM

AUGUST 1981

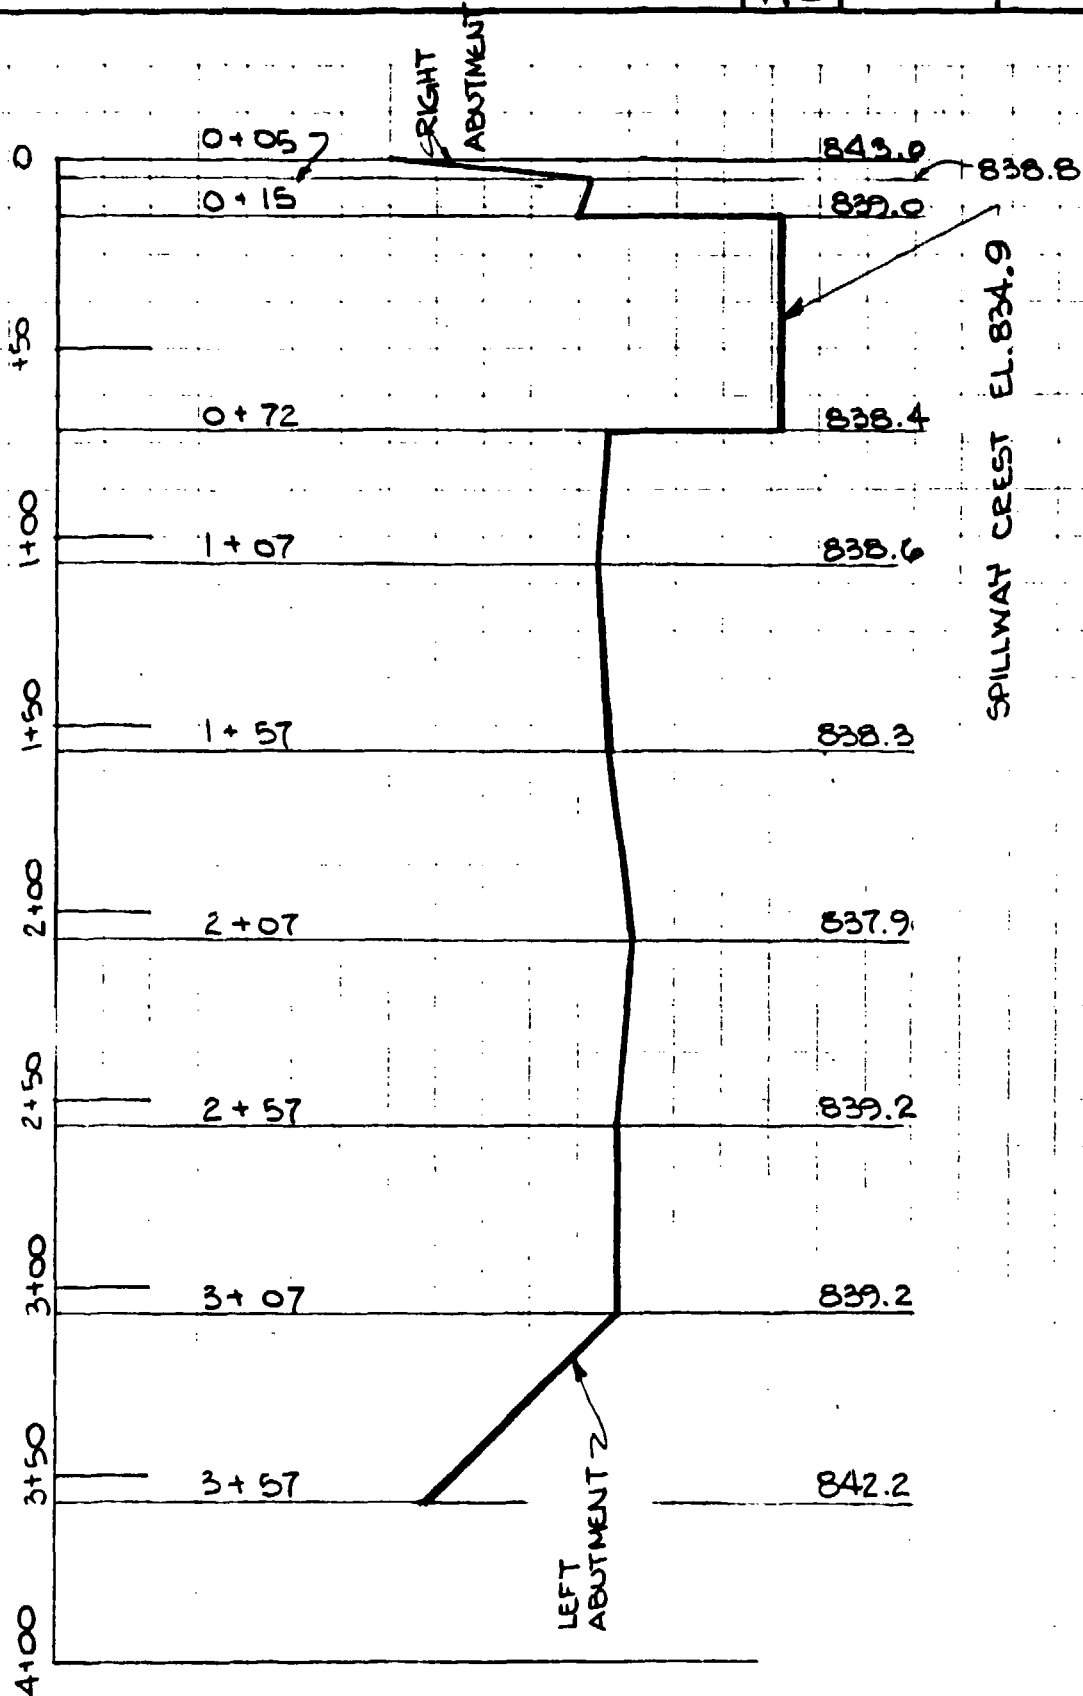
PROFILE CENTERLINE TOP OF DAM
LOOKING DOWNSTREAM

The crest of the dam is covered with grass. No signs of settlement or misalignment were observed in the embankment. A survey along the centerline of the crest of the dam was made by the inspection team and is shown in Appendix A, Sheet 11B.

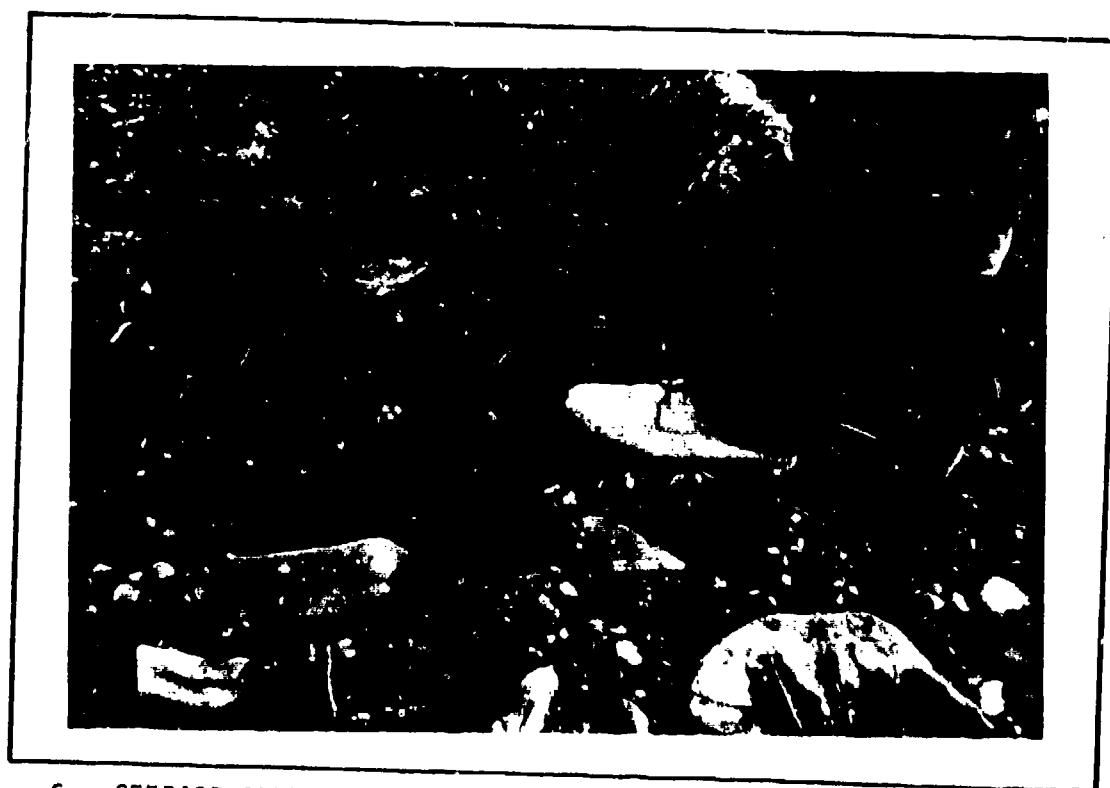
a. Visual Observations. The overall structural appearance of the dam at the time of the inspection was fair. The source of the seepage (2 gpm) observed at the downstream toe of the dam should be monitored. The irregularity of the downstream face of the dam appears to be the result of poor construction control during the widening of the crest in 1971. No cracking in the embankment was noted.

6. SEEPAGE APPROXIMATELY 5 FEET TO THE RIGHT OF OUTLET PIPE.
(5/13/81)

2. The seepage at the downstream toe of the embankment should be observed regularly for indications of a change in flow rate and/or turbidity.
